Symptom: Malfunctioning Parker Fly SN 134119BMH. Master volume control does nothing. The magnetic pickups are operational but only through the magnetic volume pot. There is no output from Piezo.

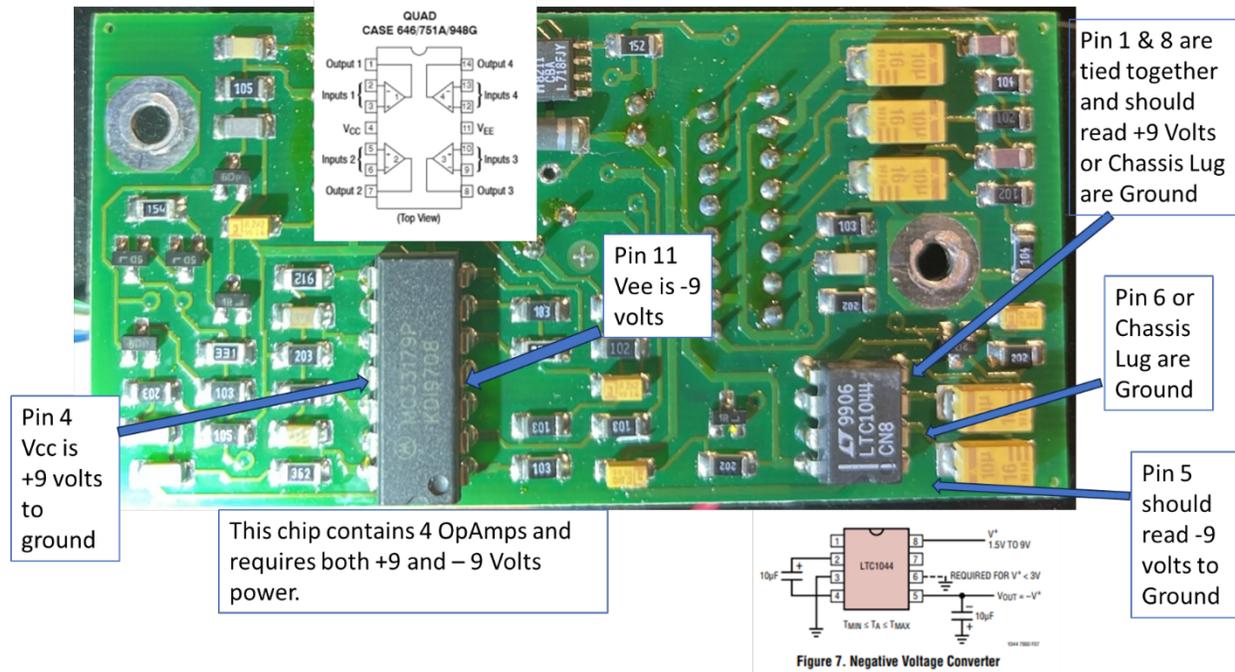
Recommend: Check the output of the LTC1044 chip to make sure that it is outputting -9 Volts DC. Also check to see that the MC33179 Quad Op Amp is powered with both +9 and -9 volts DC, referenced to Ground lug. In my case, Pin 5 of the LTC1044 was outputting +9 volts.

Discussion: The Fly main board requires both positive and negative 9 Volts. The positive 9 volts comes from the 9 volt battery. The LTC1044 provides the -9 volt supply, and only requires the two 10 uF capacitors (yellow components left of chip) to operate. It is not capable of much output power, but is critical to power the OpAmp, which needs Vcc (+9V) and Vee (-9V) to operate. It is common in modern electronics for ICs to fail much more often than passive components (resistors and ceramic capacitors.) Typically, the first troubleshooting step is to check power to ICs.

Solution: The repair performed was to replace the LTC1044. LTC1044 was sourced via E-bay and came from China. Repair requires desoldering [materials: decent temperature-controlled soldering iron, leaded solder (you can use lead-free, but more troublesome particularly if you don't do a lot of soldering), solder wick, and solder flux.] There are a lot of good YouTube videos available on how to solder electric parts. Watch a few videos and practice on some junk boards before you attempt to fix something you want to keep. Be careful how long you put the iron on the board and use lots of flux. Flux essential to good soldering. I used an IC holding socket in the repair, just in case the LTC1044 burned out again. Replacing in the future would be to just unplug and plug in a new IC. This also eliminates the possibility of over-heating and damaging IC, if you don't do a lot of soldering.
